COMPARISON OF PERFORMANCE OF E-1000 AND E-2000 IN DETACHABLE ANCHOR LINKS EXPOSED TO CYCLIC TEST CONDITIONS

W. M. Dalton,
Elisha Technologies Co. L.L.C.

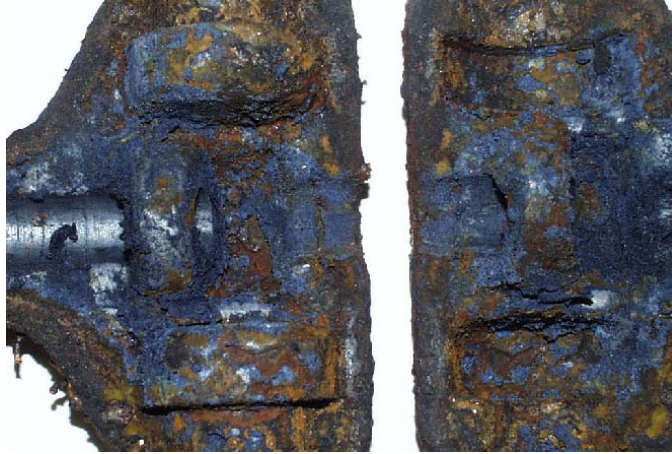
Figure 1: Internal Surfaces of Link Containing E-1000 After 150 Cycles Of Cyclic Test Exposure

Final inspection of the detachable links after exposure to 150 cycles of corrosion exposure revealed neither link pin was difficult to remove. The E-1000 link required prying to break loose the coupling plate as opposed to the E-2000 link, which only required a light tap. Both links had experience ingress of corrosion from the joints but the tapered pin areas were still protected. The E-1000 link had a greater buildup of corrosion products at affected areas of the internal surfaces compared to the E-2000 link (Figures 1 and 2).

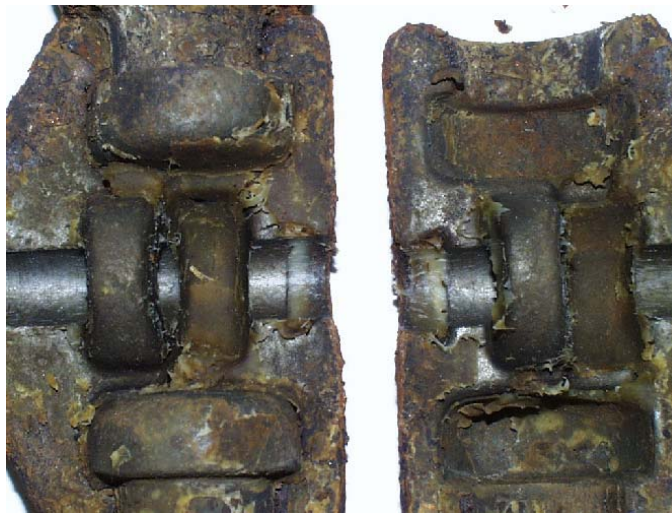
Figure 2: Interior Surfaces of Link Containing E-2000 After 150 Cycles Of Cyclic Test Exposure
